Figure 1: Copper Recovery Comparison – 3.8% Increase from PEA

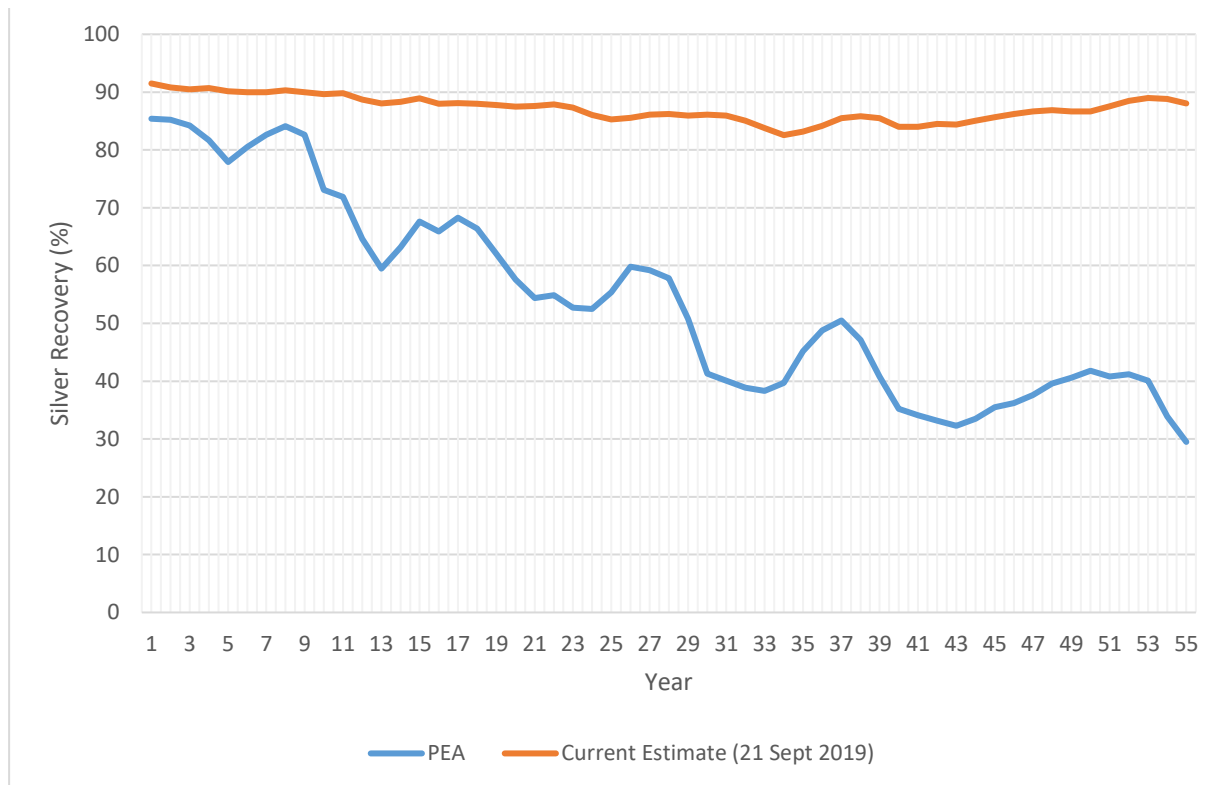
Figure 3: Silver Recovery Comparison – 28.3% Increase from PEA

Based on Locked Cycle flotation and diagnostic leach tests (ALS).

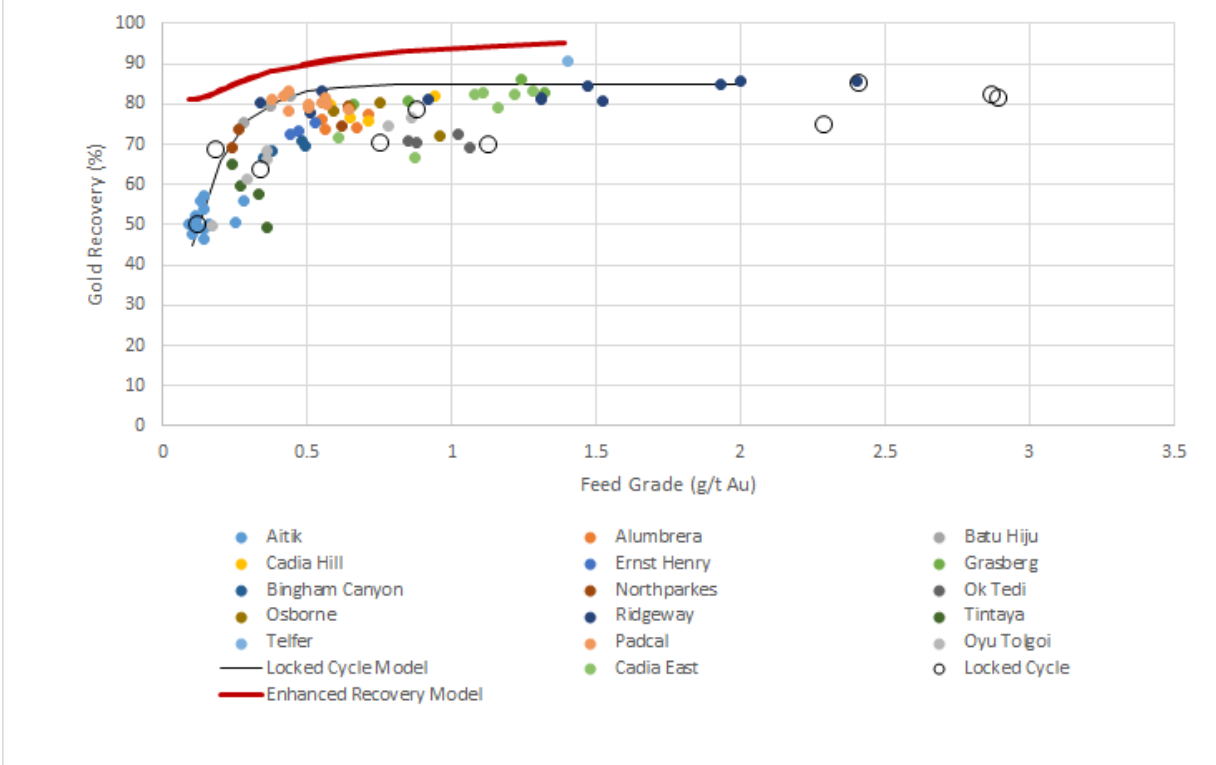
Figure 7: Gold Recovery Benchmarking
